Hobble Creek

The Hobble Creek snow course is at the top of Hobble Creek Canyon at elevation 7420 msl. It is located in a narrow north south trending meadow with both aspens and conifers on each side. This meadow eventually opens up into a wider meadow with primarily aspen on the sides. Conifers are generally large for the area. The aspect is generally north facing with a gentle slope. There is some snowmobile/recreational activity in the area that has not yet impacted the course.

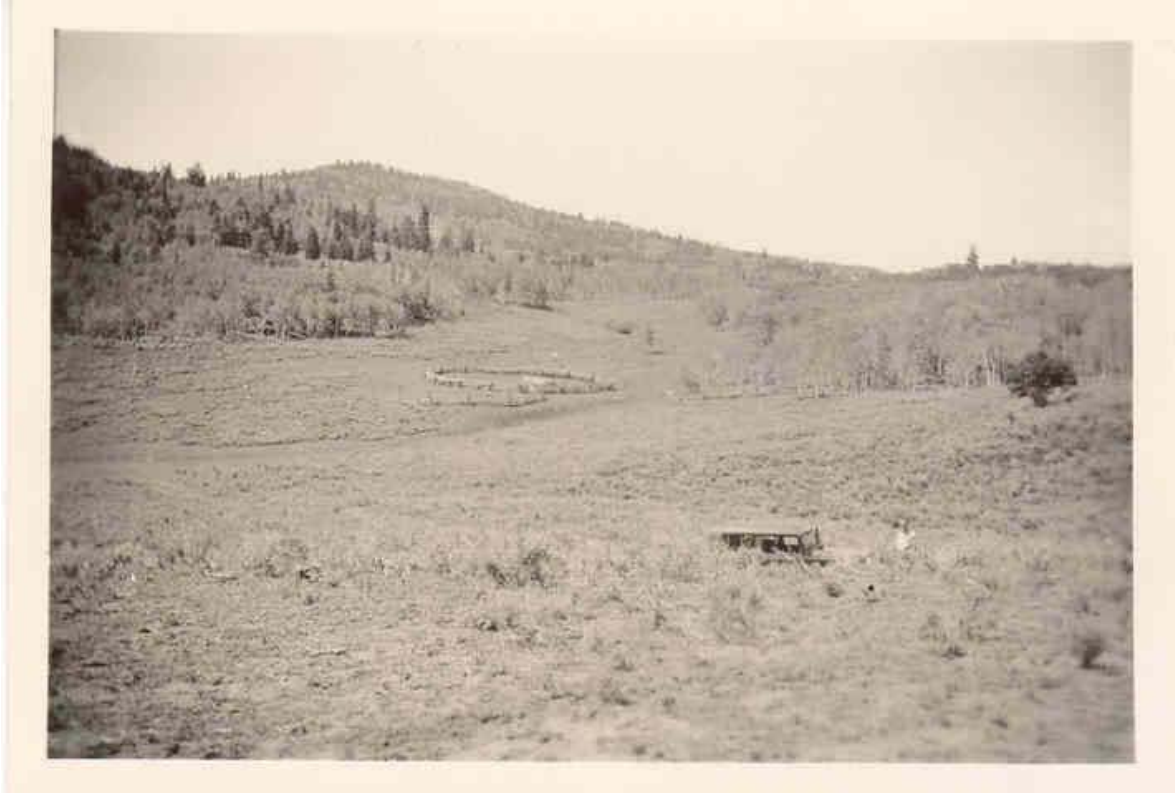
The snow course is located above the corrals up close to the conifers in the upper left of this 1936 photo.

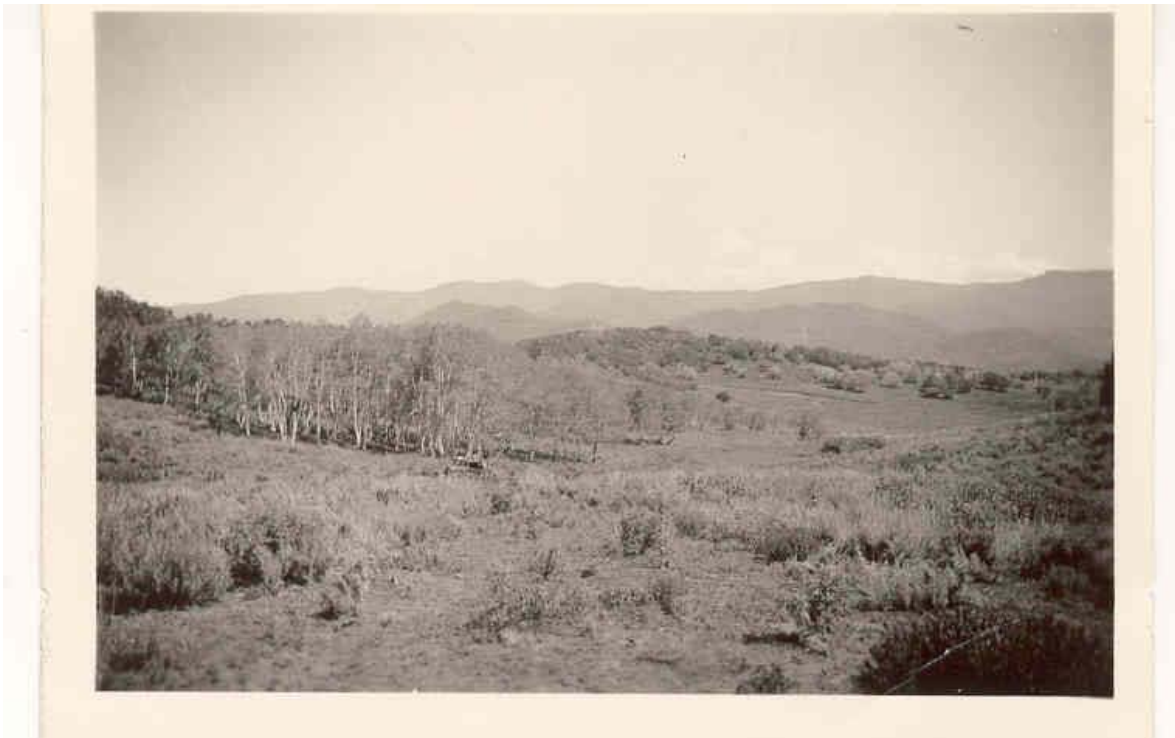
This is the upper portion of the course looking to the north.

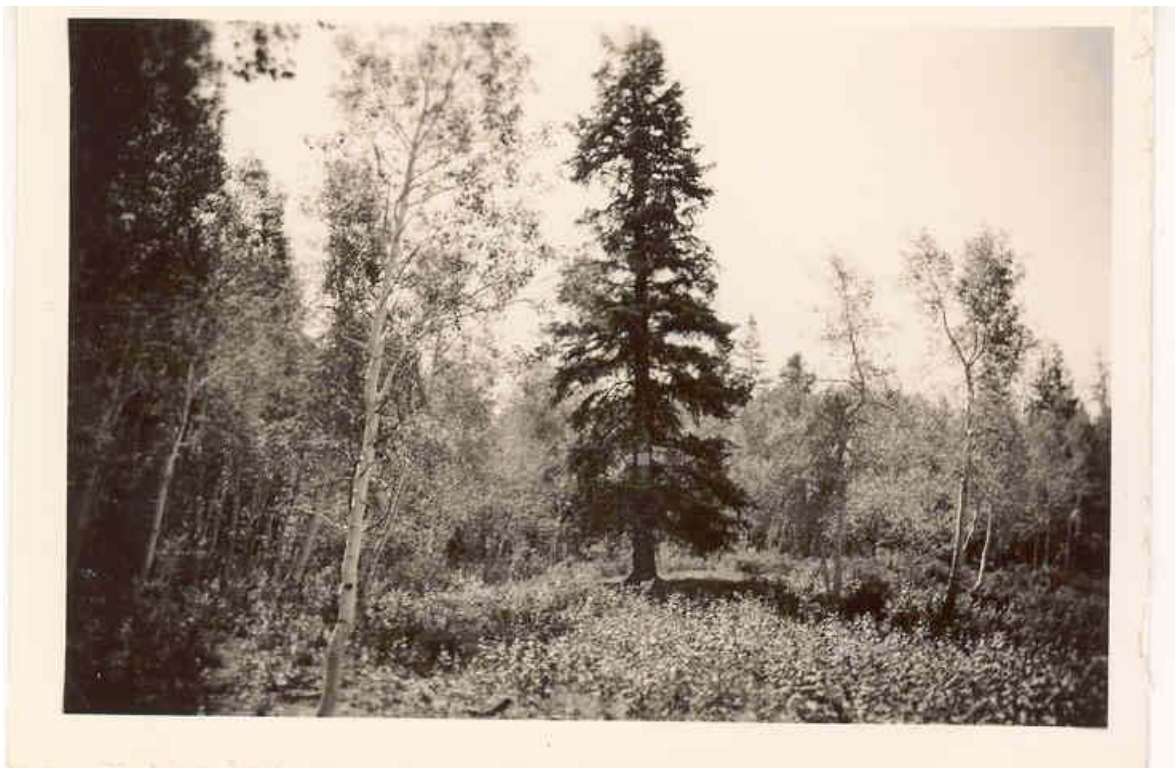
This photo is basically from the same location as the previous shot but looking up the hill to the south.

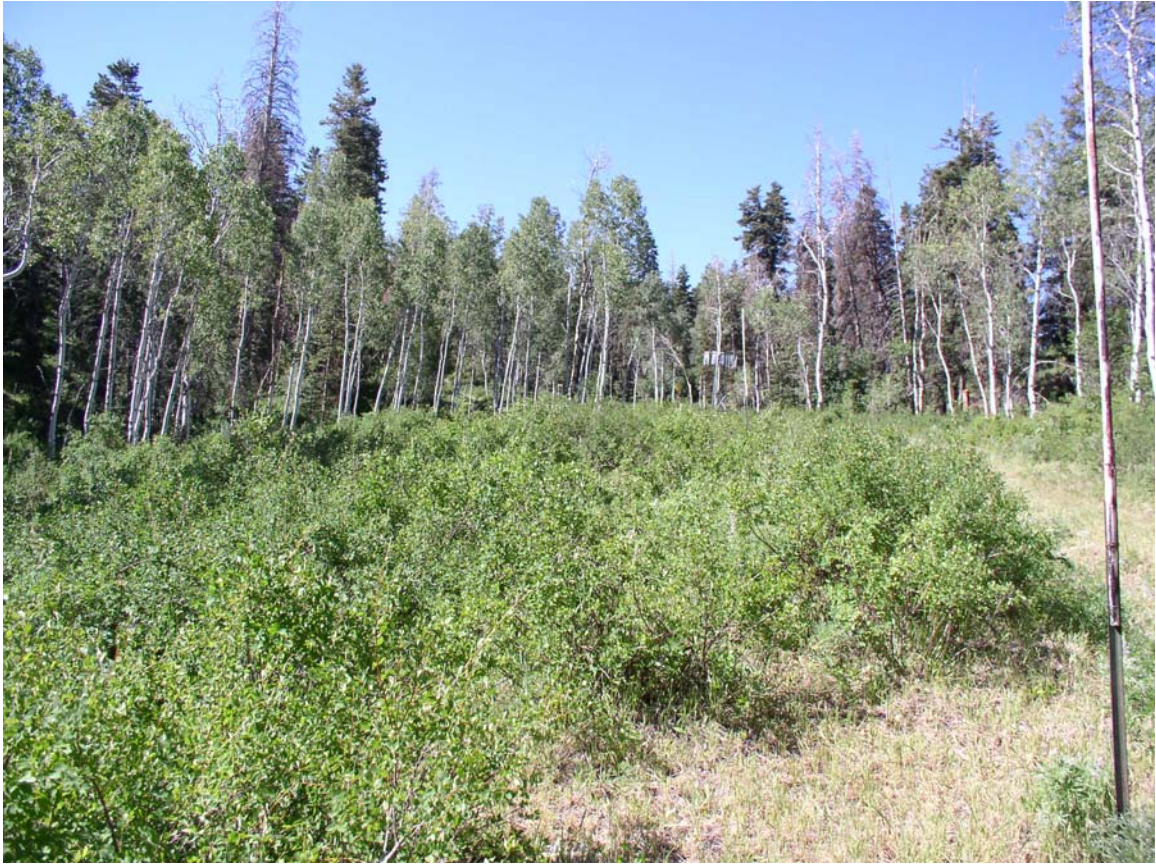
In this 2007 photo you can see that the meadow has been encroached to some degree by both aspens and conifers, the tree heights are taller and the stand of trees is denser. There is significant brush along the side of the course.

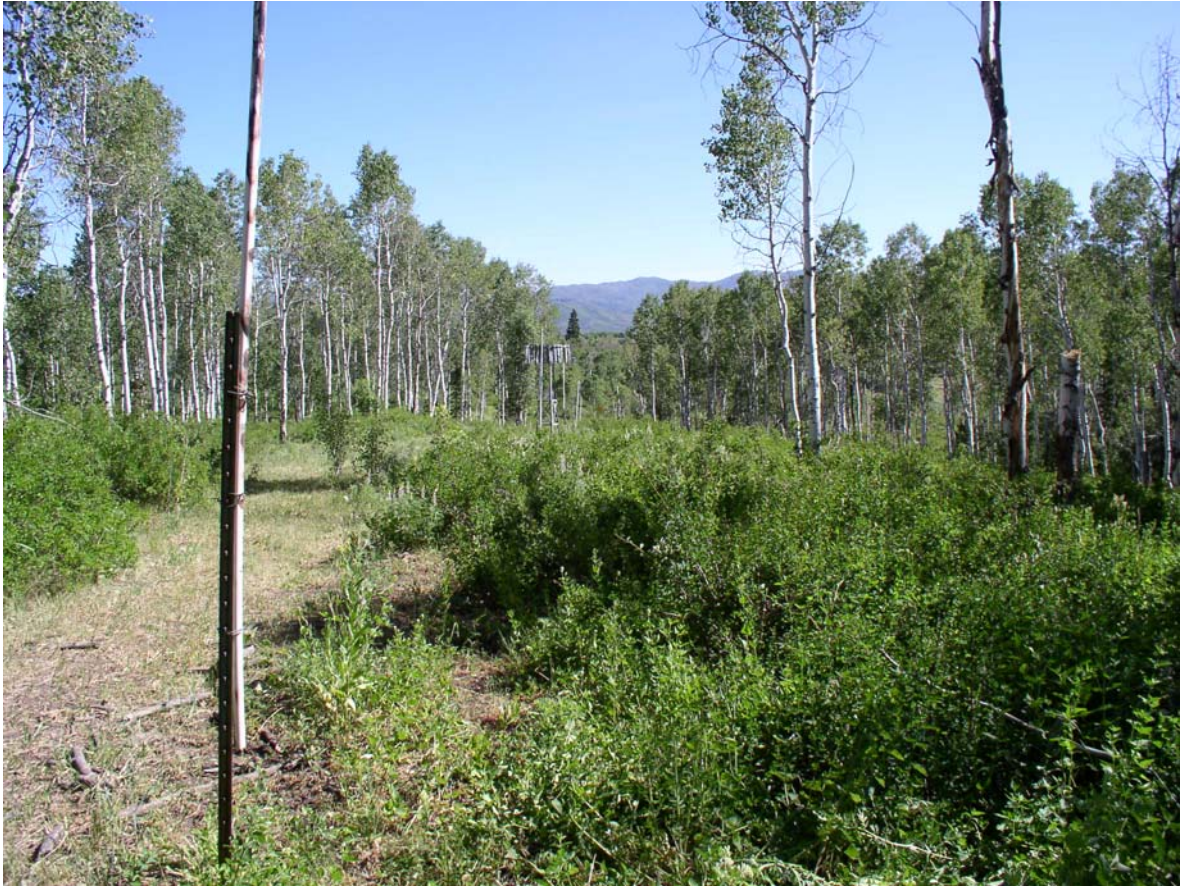
In this photo looking to the north, similar in position to the 1936 photo #2 but slightly uphill, there is a distinct narrowing of the meadow around the snow course with fairly tall aspens.

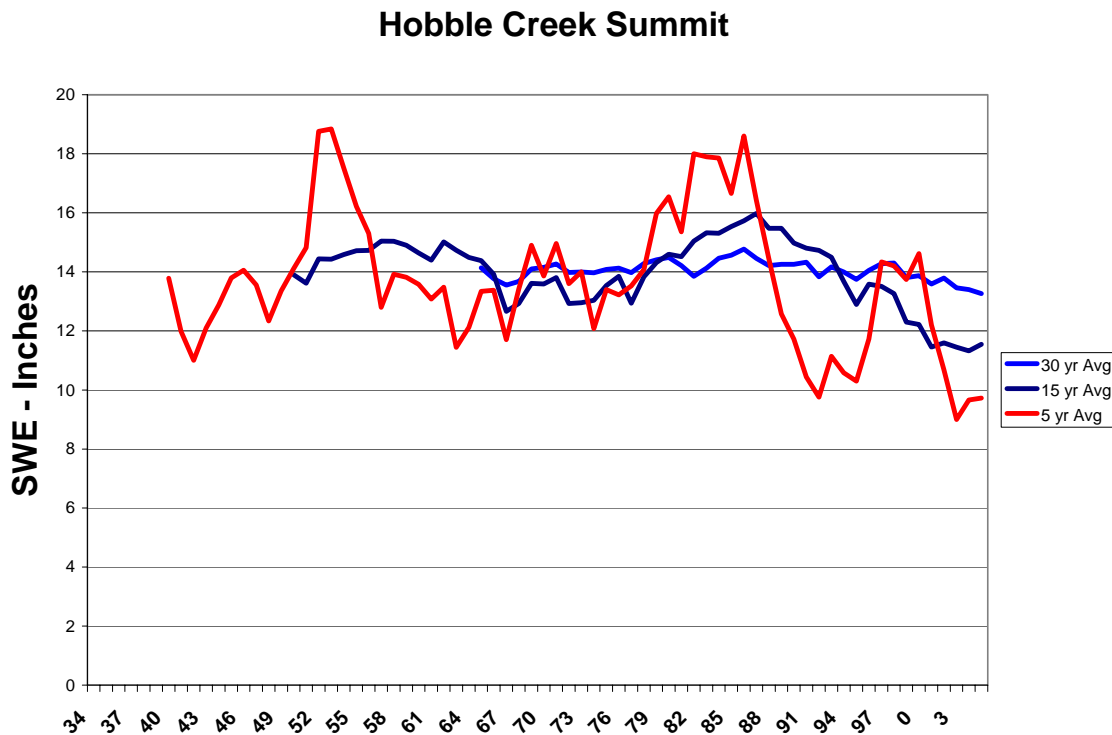
This chart shows the 5, 15 and 30 year average April 1 swe. In the 5 year trend there are some sharp ups and downs with the latter period being lower than the earlier portion of the record. The 30 year running average shows a flat trace with a little dip at the end. This site is being impacted to some degree by the encroaching and growing stand of aspens and conifers. The quantification of that impact and potentially others have yet to be determined. This site would be questionable for use in long term comparisons.
